ROCKETDYNE

R-7102

INVESTIGATION OF BIAXIAL
STRESS CORROSION
IN TWO ALLOYS
(Final Report)

Contract NAS9-6324

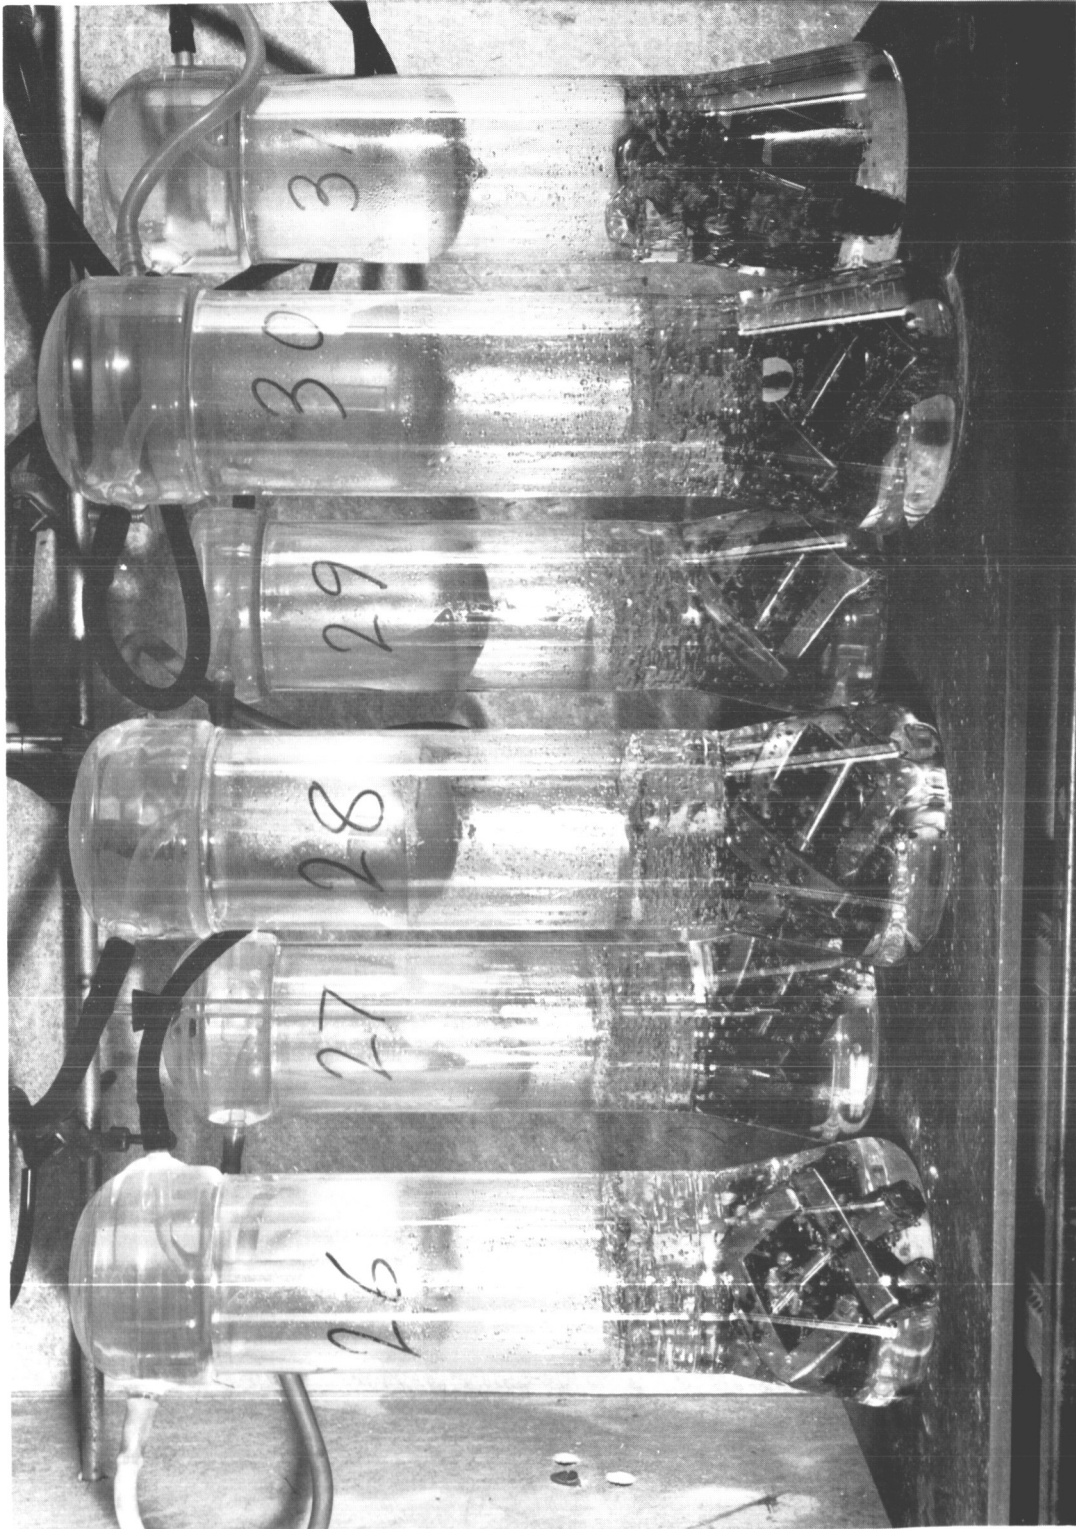
Figure 9. Boiling MgCl_2 Stress-Corrosion Test on 347 Stainless Steel

The stainless-steel specimens were continuously immersed in a constant boiling (309 F) 42-percent aqueous $MgCl_2$ solution. Each specimen was exposed to a fresh solution of $MgCl_2$ contained in a modified Erlenmeyer flask with cold finger. As many as 12 flasks could be accommodated on the hot plate which was used, although usually six tests or less were conducted at one time (Fig. 9). Several cold fingers were fabricated with passages for thermometers and tubing.
